Memorandum

Subject: Dose measurements around the NM3 target pile

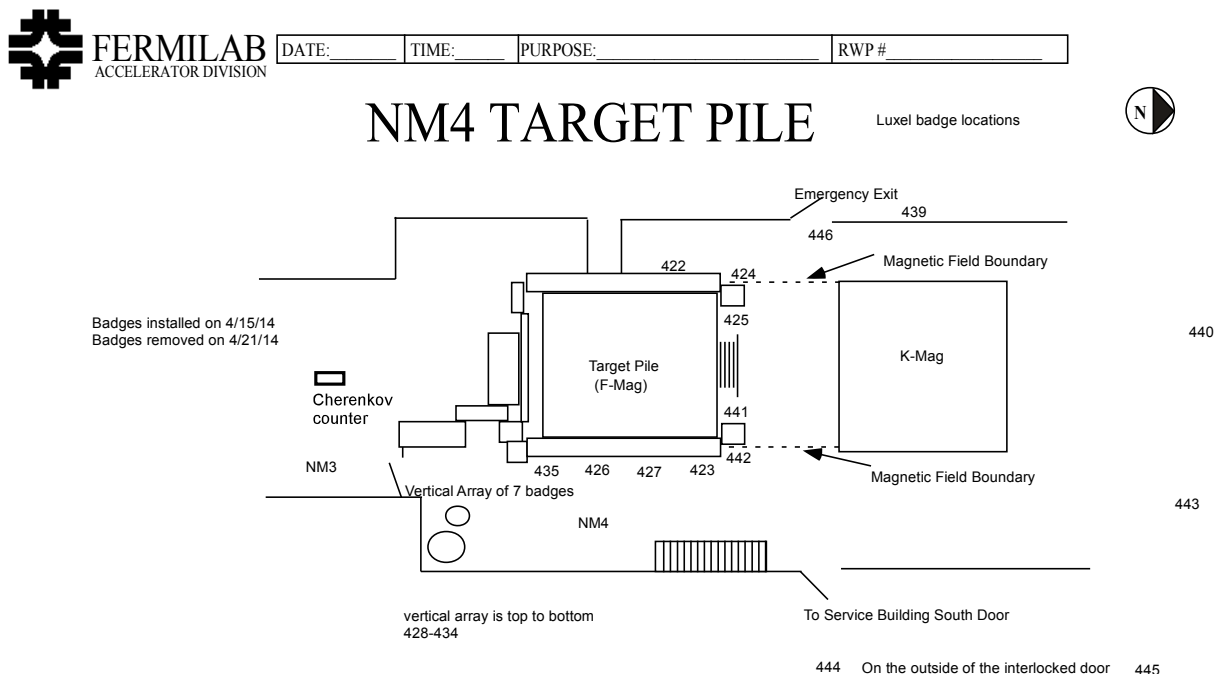
Figure 1. Location of each badge.

The badges around the target pile are at beam elevation. The badges for the vertical array were set with badge 431 at beam elevation. Then badges were placed every 2 feet up and down from the middle for a total of 6 feet above and below beam elevation. All badges were oriented with their face towards the radiation field.

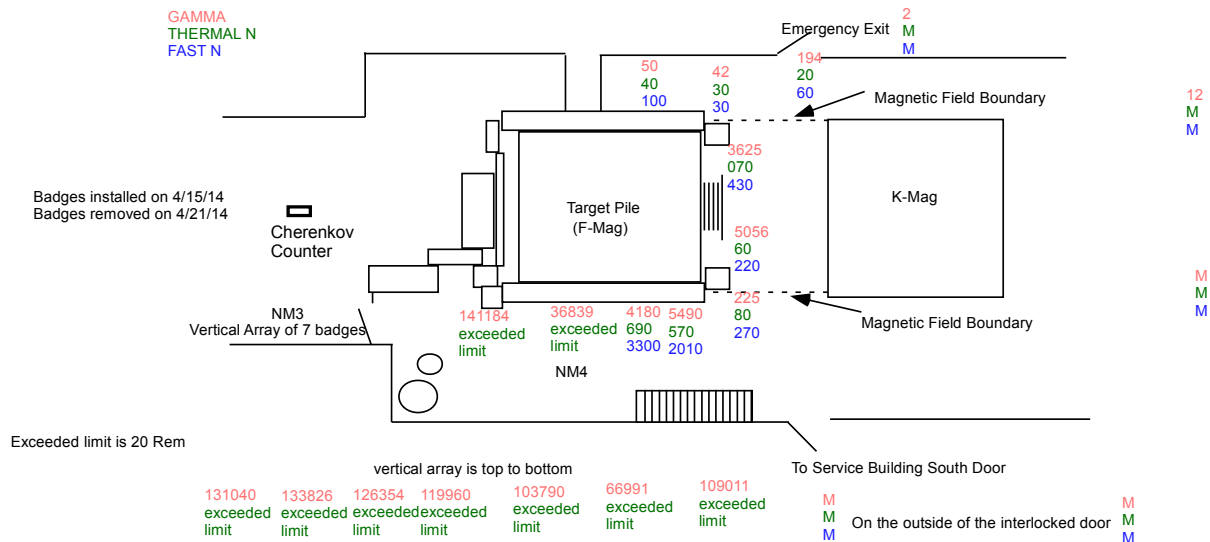
Figure 3. Badge reading in place of the badge numbers for ease of analysis.

All the badges in the vertical array and the next 2 badges going north on the east side of the target pile exceeded the limit of 20 rem. The second badge from the bottom, badge 433, had a gamma reading of about half the other badges in the array.

Badges 440 and 443 were placed on the outside of the north wall of the building and about 2 feet above the ground. This location caused them to be shielded by the concrete loading dock. Therefore are not useful for analyzing doses in the north parking lot.

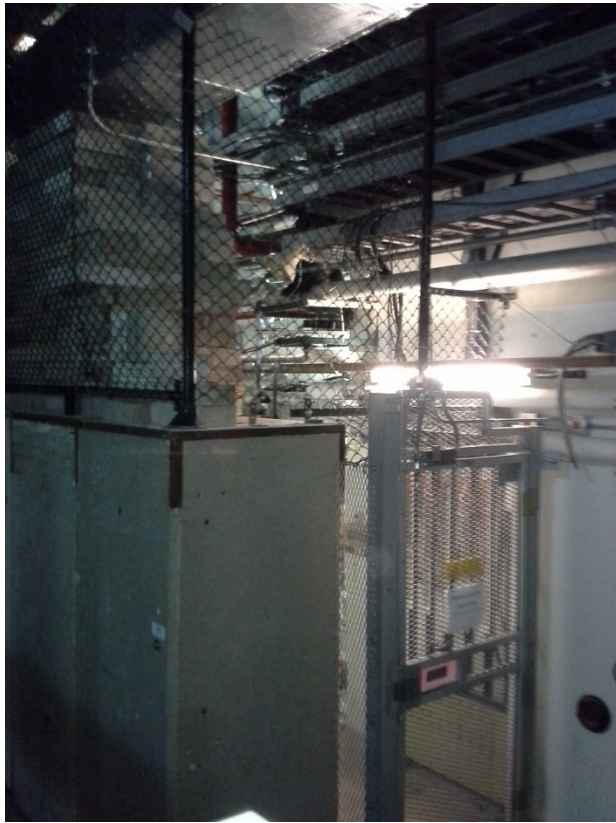
The shielding arrangement on the east side of the target pile and around the gate allows a path for a high gamma and neutron flux to pass by the shielding and thus is allowing higher than desired dose rates in the north parking lot. The actual control room in the building is shielded by an additional 8 feet of dirt and concrete. It is also protected by interlocked chipmunks and monitored with an area badge. The following pictures are of the shielding to the east side of the target pile from the location of the Cherenkov counter.

Picture 1. Looking at the NM3/NM4 gate.

Though the neutron portions of the badges on the east side of the target pile were reporting “Exceeding Limit”, they demonstrated that this region is the weakest portion of the shielding. To be allowed to run at a higher intensity shielding configuration should be addressed. Or the parking lot to the north side of the building, directly downstream of the target hall, needs to be fenced off and posted as a radiation area.

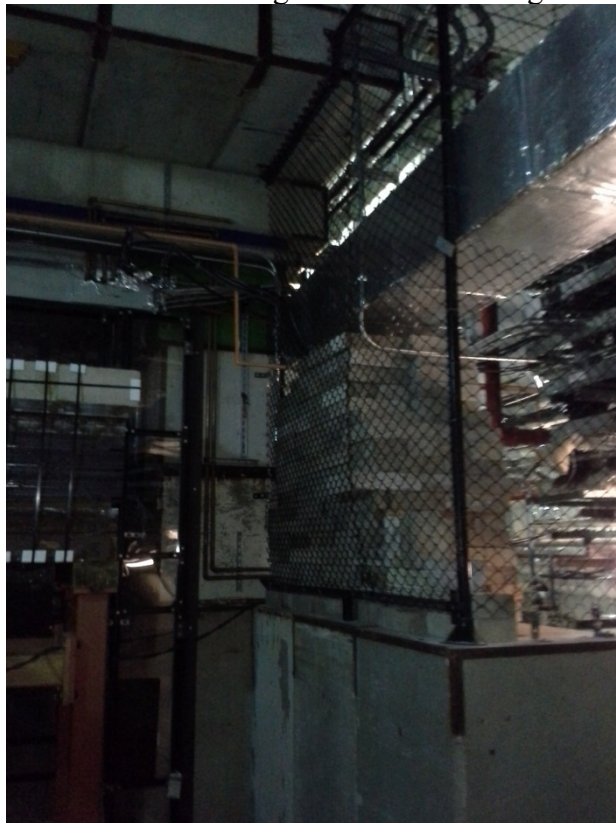
Picture 2. Target pile and east side hand stacked blocks.
